Failure Analysis:  
Popcorn Crack

A customer provided three devices that were failures and wanted acoustic microscopy performed in order to see the internal features before doing a destructive analysis.

Packages: BGA, PLCC-84, SOIC-8 (mounted to PCB)

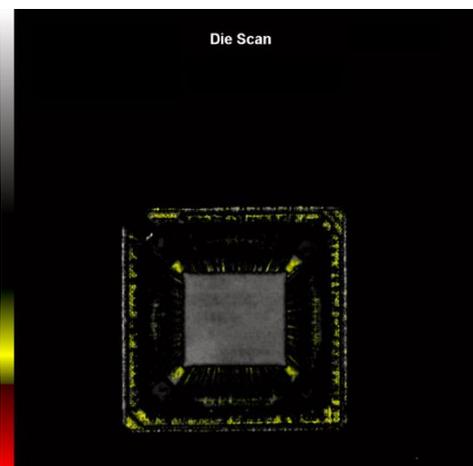
No delamination visible at the die surface.

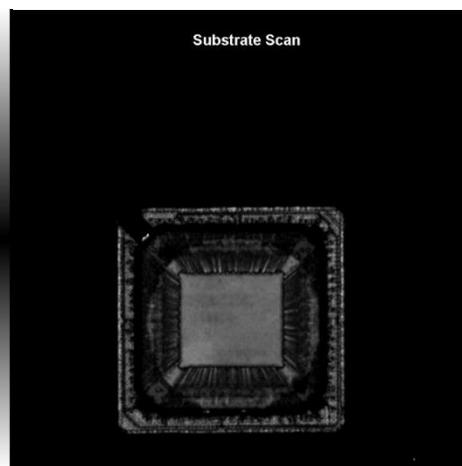
Evidence of a circular pattern of delamination or cracking is visible at the substrate.

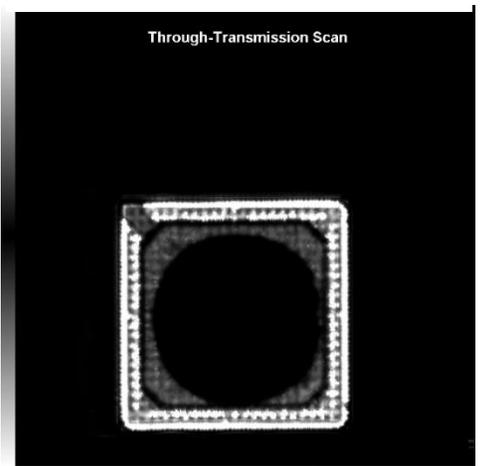
The extent of the package crack is clearly visible in the through-transmission image. The crack’s circular pattern is characteristic of a moisture-induced “popcorn crack.”

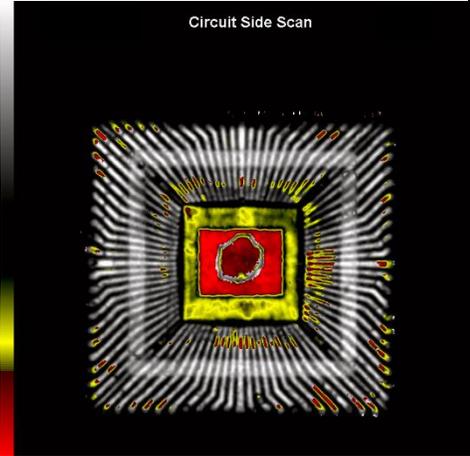
Extensive delamination is visible at the die surface, paddle, and some areas of the lead fingers.

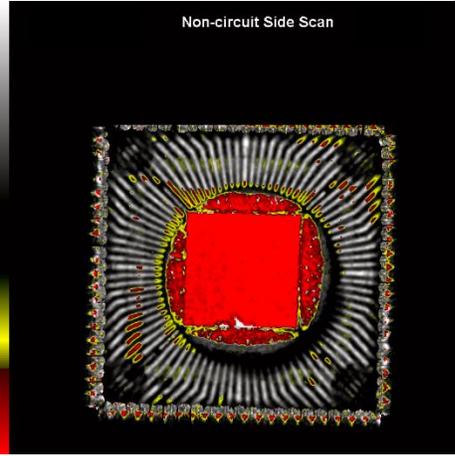
A circular pattern of delamination and cracking is visible on the bottomside of the part.

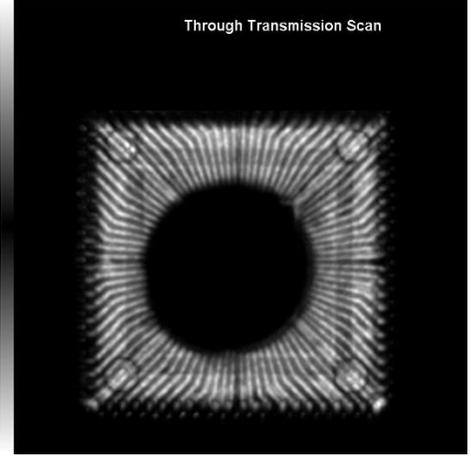
The “popcorn crack” is confirmed by the through-transmission image. In this instance, the crack extends downward from the edge of the paddle toward the bottom of the package.

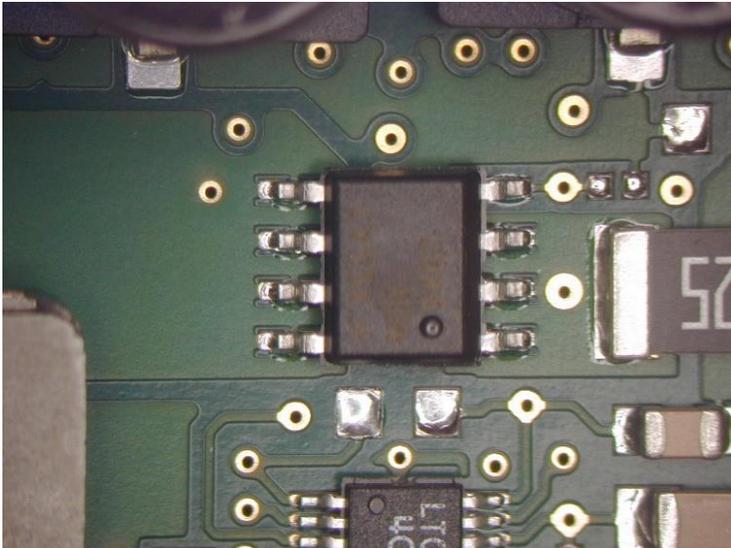
Optical image of device mounted to PCB.

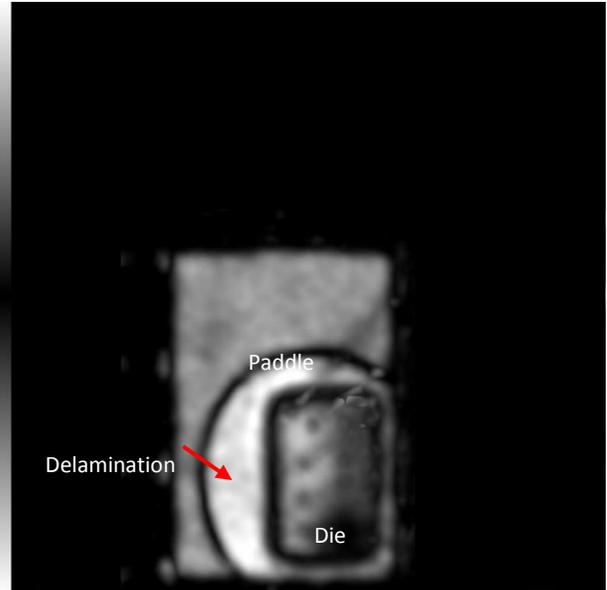
Acoustic image showing delamination at the paddle. Although no evidence of package cracking is present, the delamination is characteristic of a moisture-induced failure.
