Case Study: CSAM Evaluation for GEIA-0006 Solder Dip Process

Package Type: TO274AA-3

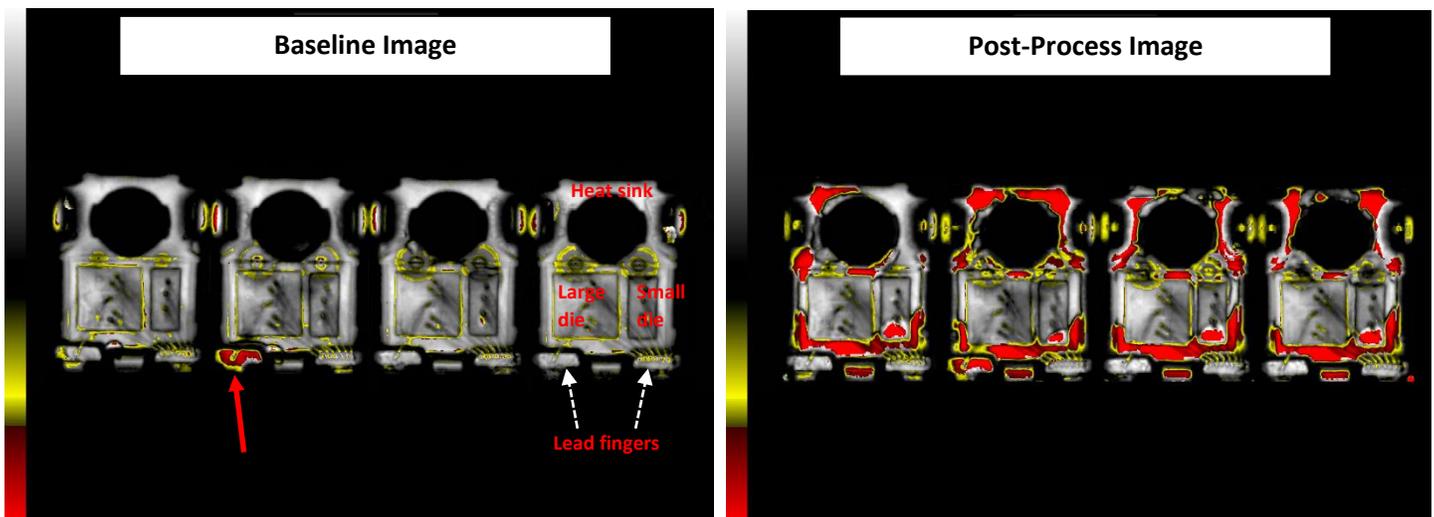
At the completion of the solder dip process, the lot was reinspected. A significant increase in delamination was observed in all devices. The delamination resulted in rejection of the lot due both to failure to meet the J-STD-020 criteria and to the fact that the delamination represented an increase of more than 10%, which is disallowed by GEIA-0006 Method 300.

During the baseline inspection very minor paddle delamination was noted in some devices. One device exhibited leadframe delamination (see arrow) which affects a wirebond location. This finding does not meet the J-STD-020 criteria.

Increased delamination was observed in all devices as compared to the baseline inspection. All devices exhibited delamination between the mold compound and the top of the small die and between the mold compound and the top of the heat sink.

Subsequent investigation determined that the solder dip process had been properly controlled. Inherent weakness within the package, resulting in inability to withstand the heat required to adequately strip and replate the exposed heat sink, was ultimately determined to be the cause of the poor SAM result. A different batch of parts – same part number but different date code – survived the same retraining process with no ill effects (see images below).

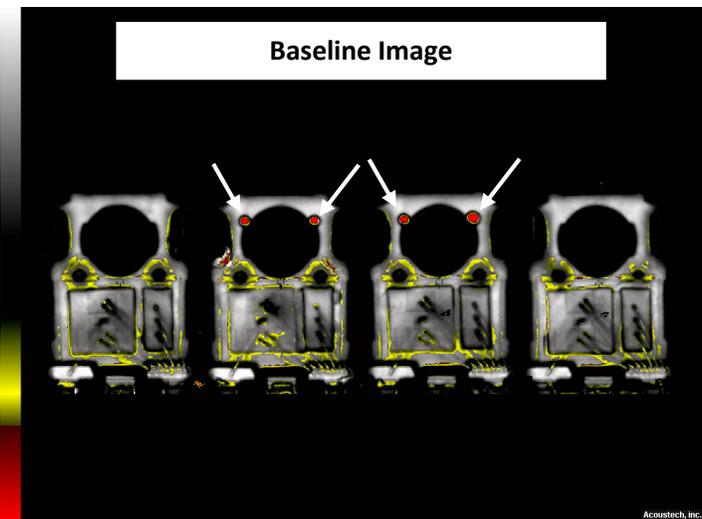
Baseline image of a different date code. Minor areas of delamination are visible at the heat sink in two samples.

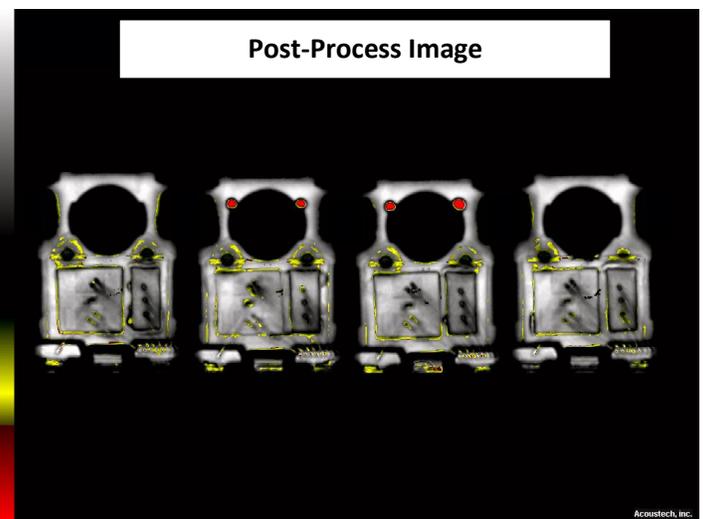
No changes following solder dip.
