# **A Case Study of PEMS Susceptible to Die Surface Delamination and Their Behavior During Thermal Excursions**

Kerry D. Oren

Senior Failure Analysis Engineer

ITT Aerospace/Communications

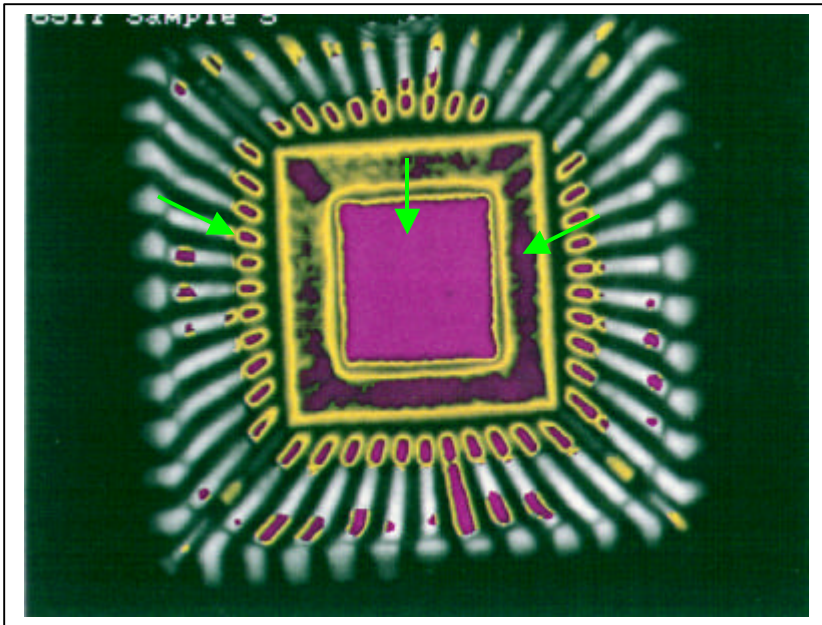
**FIGURE 1** Acoustic Image of one of the failures, which was 100% delaminated over the die surface (center arrow). The top side of the die paddle was also 100% delaminated, along with numerous areas on the leadframe elements.

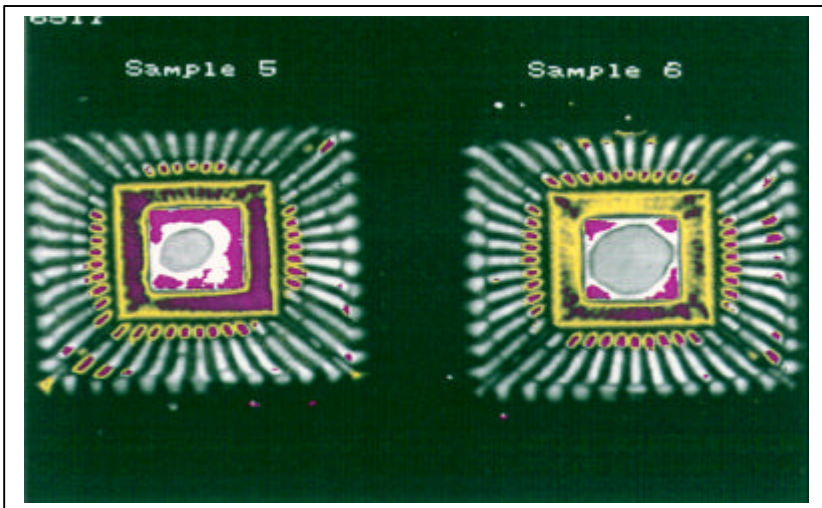
**FIGURE 2** Two other failures, partially delaminated over the die surface.

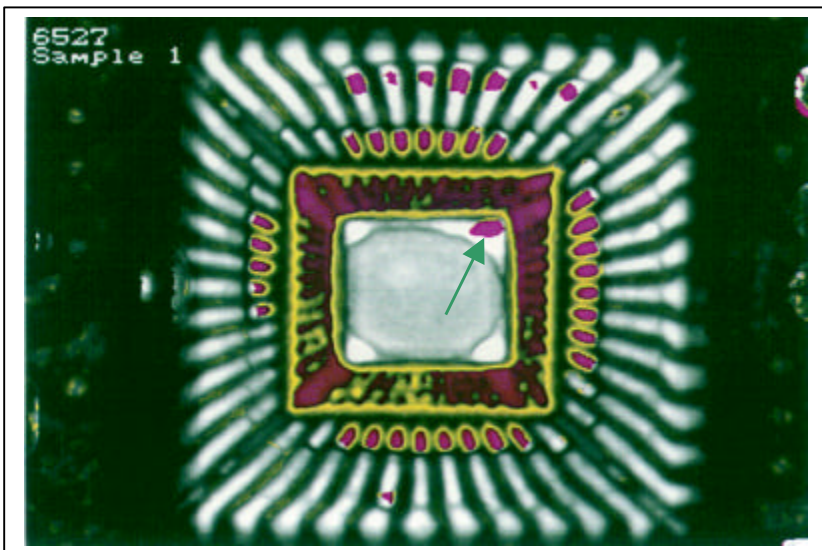
**FIGURE 3** A device still attached to a board. Die surface has some poorly bonded areas (white), which transition into full delamination (arrow).

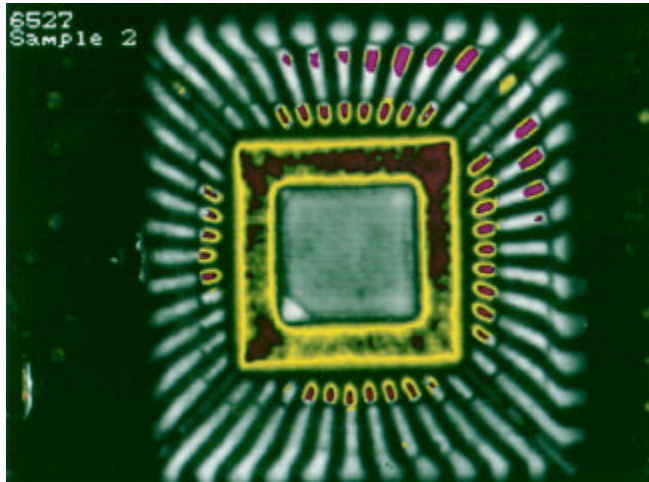
**FIGURE 4** A device still on the board, with only one corner of the die surface poorly bonded.

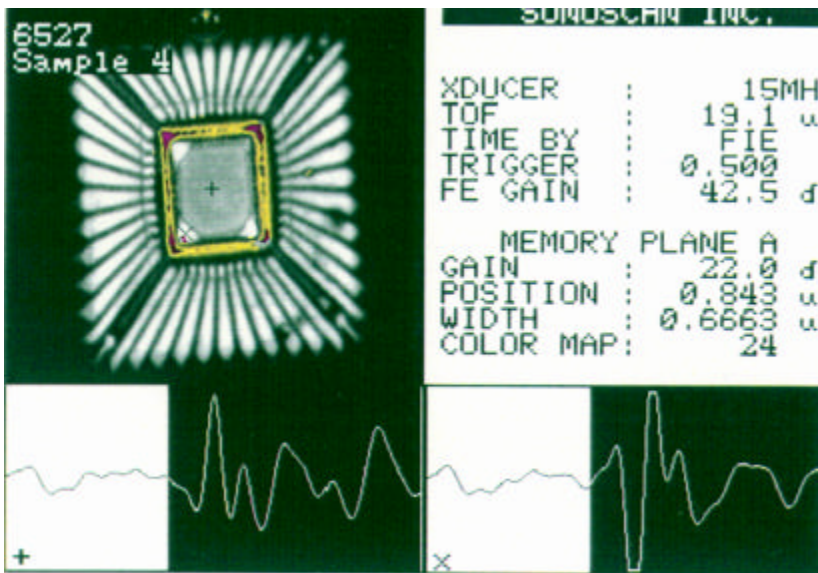
**FIGURE 5** This figure shows the echograms associated with the poorly bonded condition. The echogram at "+" shows the expected positive echo associated with a well-bonded area. At "x", the positive echo is preceded by a negative echo, indicating poor bonding. A delaminated area would have a fully negative (inverted) echo.

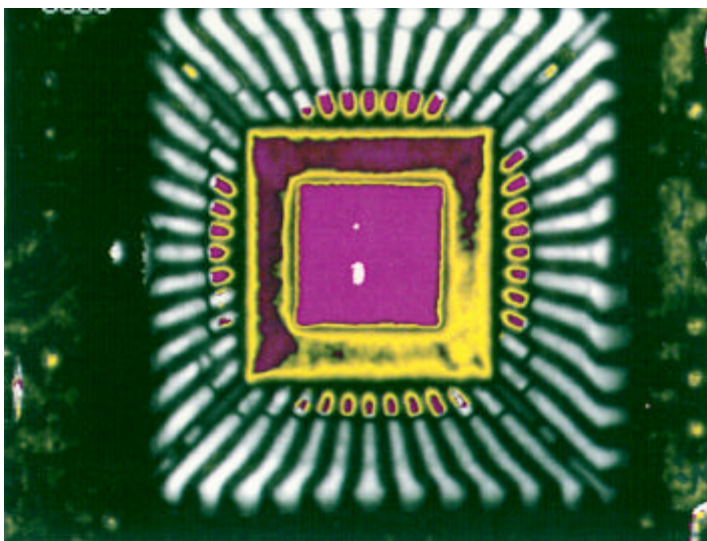
**FIGURE 6** This is the device that failed due to bond damage (still on the board). Die surface is 100% delaminated.

During this timeframe, another failure was located. This time it was suspected as being related to the die surface delamination, because it was intermittently open at high temperatures. It was submitted while still on the board. C-SAM inspection confirmed the die surface was 100% delaminated [fig. 6].

Initial scanning electron microscope (SEM) inspection of the wirebonds found no defects. However, pull testing found that several bonds were significantly degraded, pulling at about 50% of the strength of a "good" bond. One pulled at zero force. These degraded bonds failed due to the lifting of the ball bond, a result of a silicon chipout [fig. 7]. This is typical of ball bond damage as a result of delamination of the molding compound at the die surface<sup>3,4</sup>.

The conclusion was that this failure was caused by the delamination, the first of the failures to be so linked. As a result of this finding, additional numerous (non-failing) devices were C-SAM inspected while still on boards. Forty-eight percent of the samples examined showed some areas of poor adhesion (not yet delamination). Nineteen percent had some areas of actual delamination. A total of 67% of the samples showed some sort of adhesion problem at the die surface/molding compound interface.

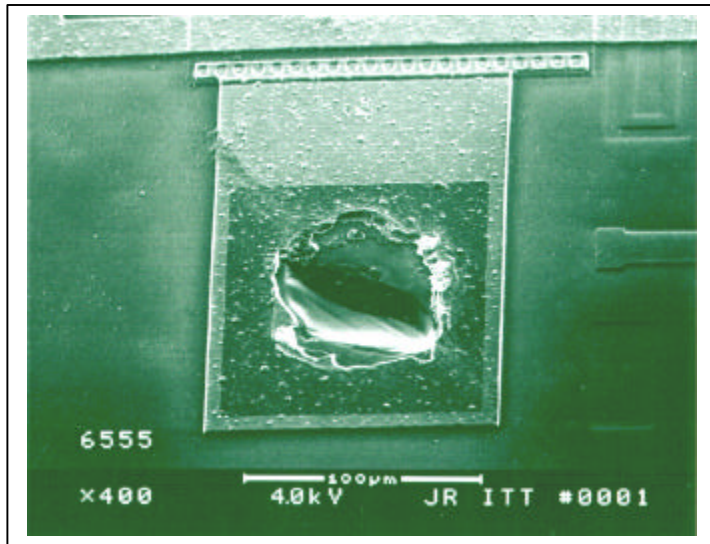
**FIGURE 7** This SEM micrograph shows the bond pad that was under the bond that lifted up with zero force. The chipout in the silicon is readily apparent.

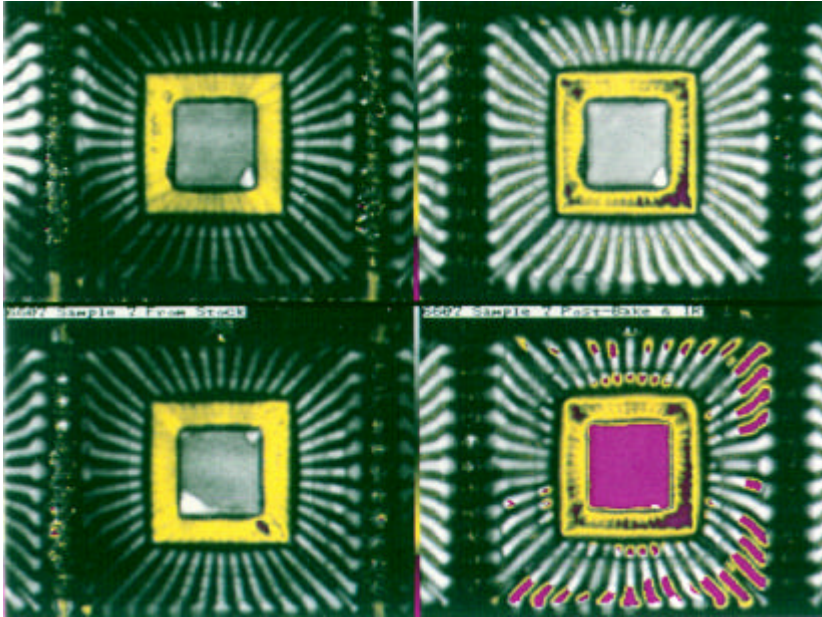
There was no pattern associated with the parts which changed. One part which had only small areas that were poorly bonded, delaminated completely during the IR reflow; other parts which had significant areas of delamination remained stable.

**FIGURE 8** These images show the difficulty in predicting how the die surface will behave. Both D/C 9417 parts had small areas of poor bonding; the sample at the bottom fully delaminated during IR reflow, while the top sample remained unchanged. (In figs. 8-10, left images are initial, and right images are post-IR reflow.)

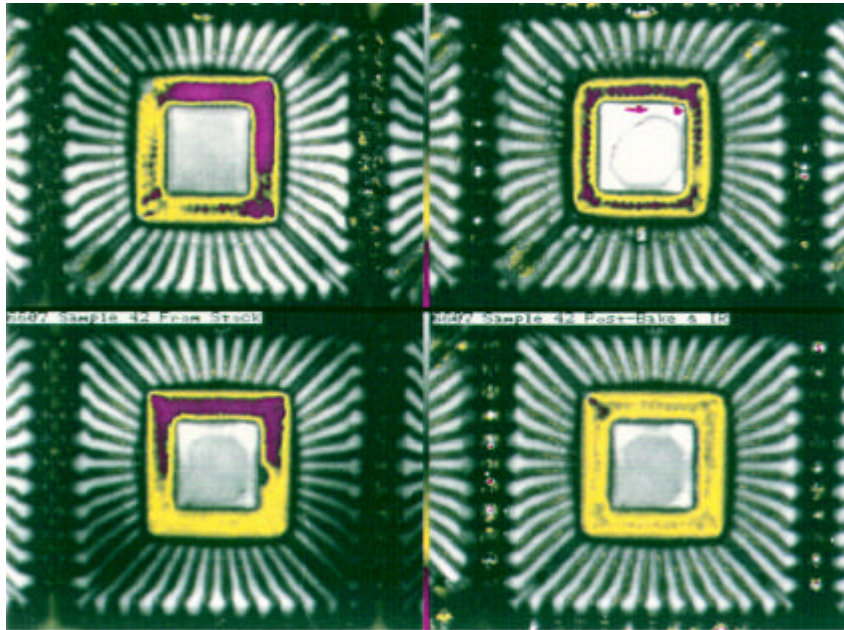
**FIGURE 9** The top image shows a D/C 9431 part which has a large area of the die surface poorly bonded following IR reflow. The bottom shows a D/C 9446 part which initially showed some poor bonding, and remained unchanged after IR reflow.

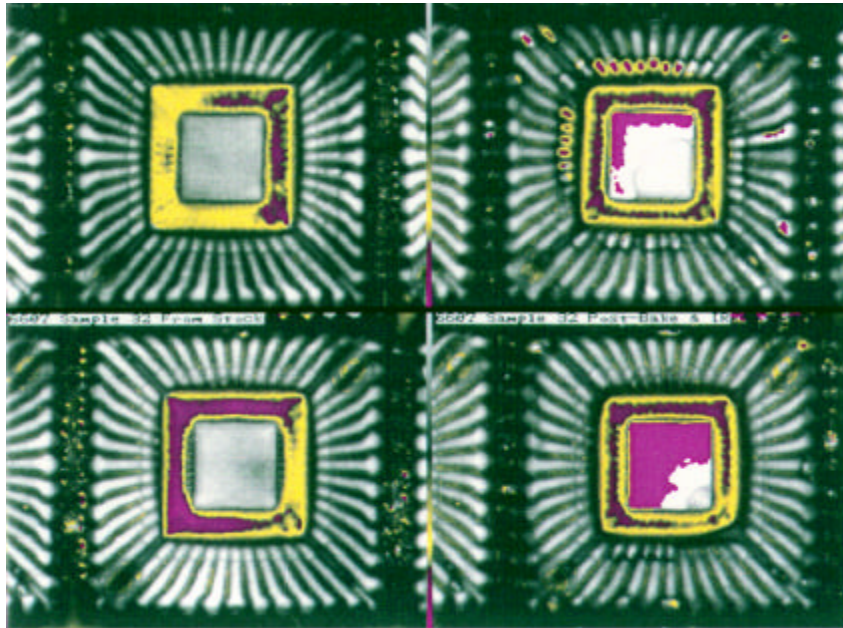
**FIGURE 10** Two D/C 9431 parts which exhibited severe die surface delamination after IT reflow (both were pre-baked).

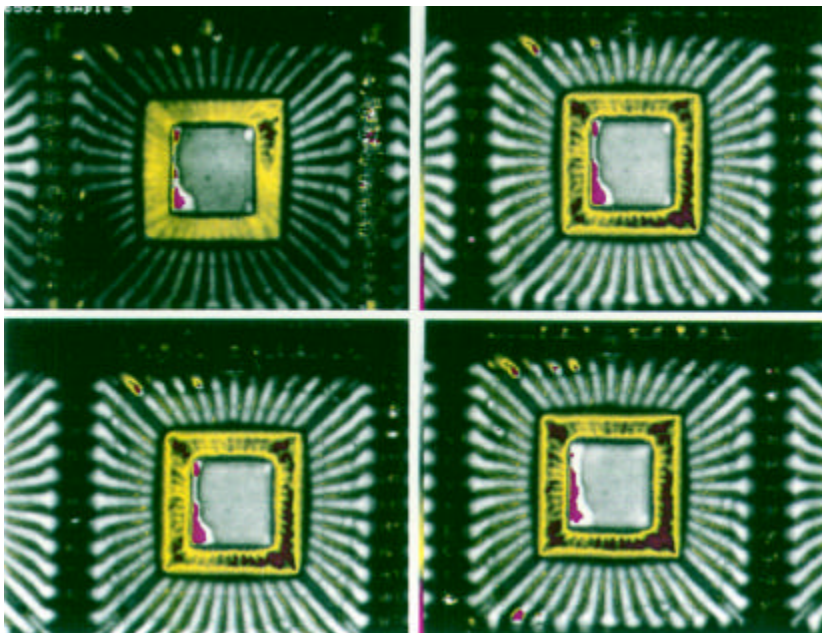
**FIGURE 11** This was a D/C 9417 part which initially had die surface delamination. Upper left is initial image; upper right is post-IR reflow; lower left is after wave solder; lower right is after 105 thermal shocks. After 105 thermal shocks, there was a small increase in the area of delamination. Otherwise, the part was stable.

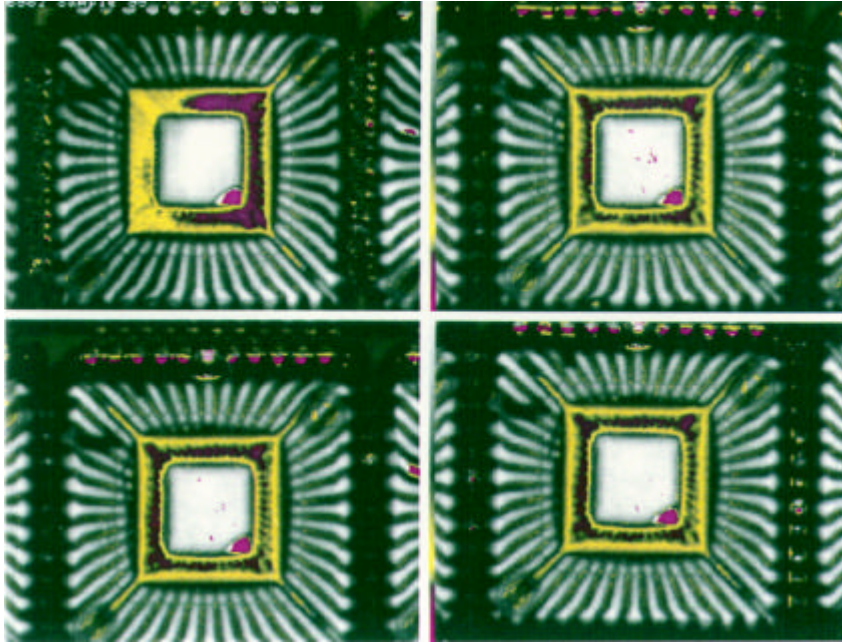
**FIGURE 12** A D/C 9431 part with die surface delamination, which remained unchanged after the same four steps in figure 11.
