THE CRITICAL ANALYTIC STEPS FOR A BIT LOSS FAILURE

A recent case involved a series of failures of an EEPROM due to random bit loss. Within hours to days after programming one or more bits would be lost. There appeared to be some relation to the packaging date code. The chart below was developed to provide an organized approach to solving the problem.

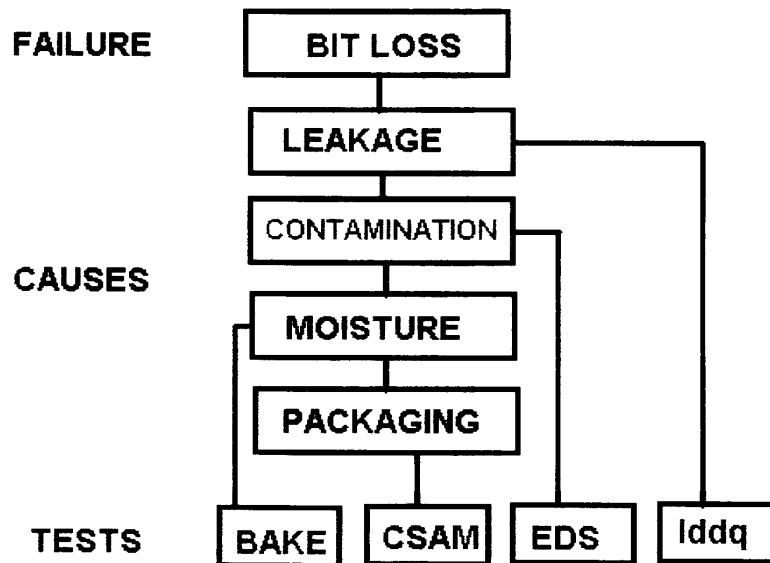
ANALYSIS STEPS

As shown, the primary causes were assumed to be:

- Iddq leakage
- Surface contamination
- Moisture on the surface
- Package delamination

These tests showed that the root cause was package delamination due to poor molding procedures. The second cause was human contamination in the assembly operation. These factors allowed moisture to create localized leakage and bit loss.
