EVALUATION OF AN AUTOMOTIVE FLUID LINE ASSEMBLY USING ACOUSTIC MICROIMAGING

Jon A. Roth
AcousTech Inc.
10542 Coldwater Road, Suite B
Fort Wayne, IN 46845
Phone: 219.637.2167
Fax: 219.637.4128
jon.roth@acoustech-inc.com

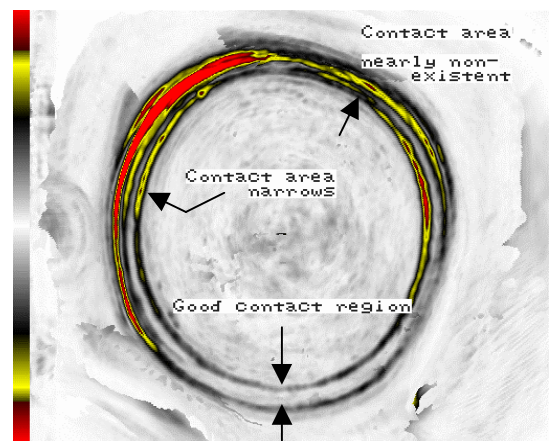
By setting a wide gate and focusing at a depth estimated to be roughly the center of the desired depth of field, promising results were obtained. Using a 15MHz transducer and a symmetrical, or amplitude, map with gray at the center and yellow/red at both extremes, areas of good contact in the seal region appeared as a uniform gray band. In areas of reduced or no contact, the gray band was thinner or nonexistent as red/yellow encroached into the contact region (figure 3).

Figure 3 Initial acoustic image of failed assembly, showing seal between tube and threadsaver.

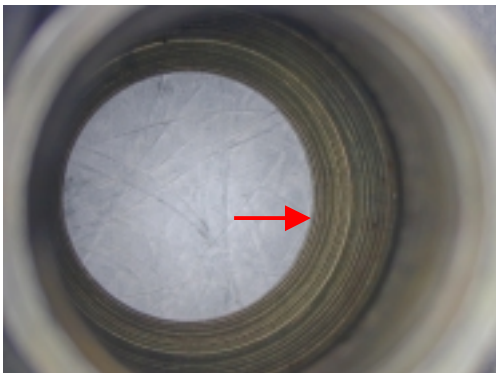
Using that standard, considerable improvement to the AMI technique was obtained, along with increased confidence in the results. First, it was observed that machined grooves were present on the underside of the tube nut (figure 5). The grooves were quite deep and were very apparent in the images. It was reasoned that in a well-bonded case, where the tube nut had tightly compressed the tube against the threadsaver, the grooves would be less visible, since they would be compressed or filled with material.

Figure 5 View of tube nut from bottom side. Machining grooves present on angled mating surface (at arrow).

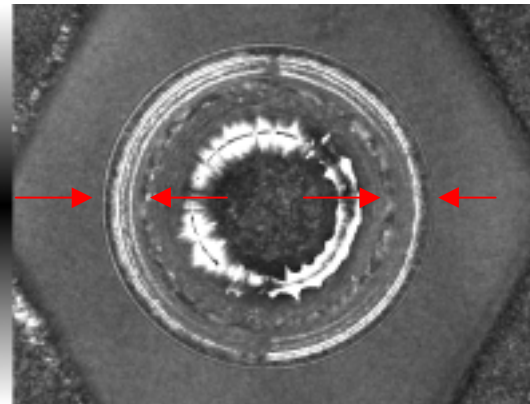
Figure 9 Acoustic image of 10Nm sample, showing entire seal area (bounded by arrows). Poor seal is identified by white bands within the seal area.

portion of the seal appears well-compressed, as evidenced by a uniform gray band (between arrows on right). Much of the rest of the seal area contains white bands, indicating a large signal reflection and, hence, poor compression of the nut/tube/threadsaver system.

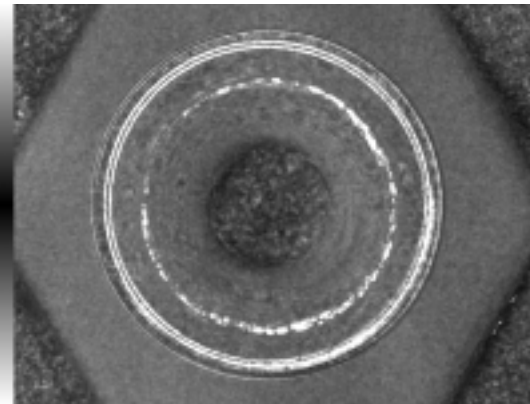
By comparison, samples from the 27.5Nm group exhibited good compression around the entire seal, appearing as a uniform gray band due to the low amplitude reflections received from good metal to metal contact (figure 10). At the opposite extreme, the failed sample appeared to exhibit a near complete lack of compression (figure 11). Samples from the 17.5Nm and 22Nm groups exhibited better seals than those from the 10Nm group, but were not as good as those from the 27.5Nm group. Side loading during torquing appeared to further degrade seal quality.

Figure 10 Acoustic image of 27.5Nm sample showing uniform gray band throughout seal region.

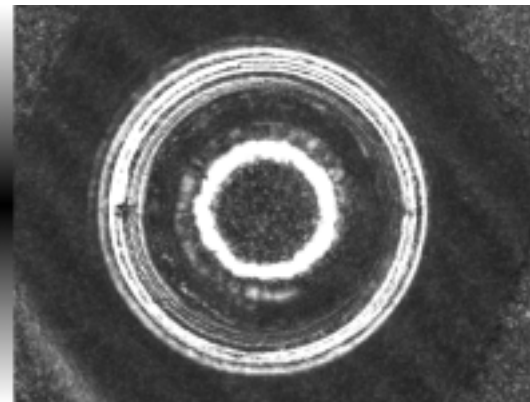
Figure 11 Acoustic image of failed assembly showing near complete lack of seal, as evidenced by white bands within seal area.

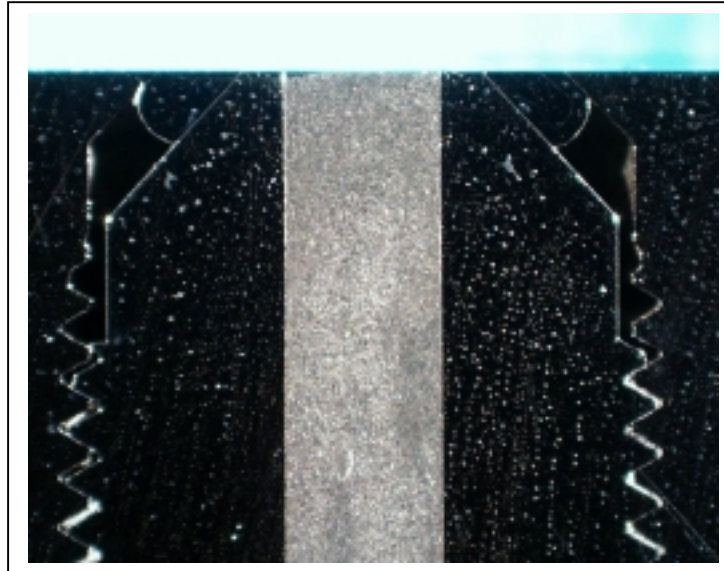
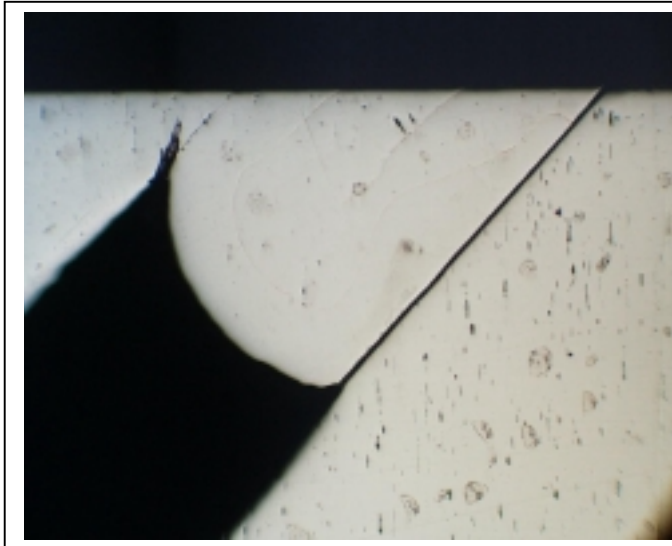
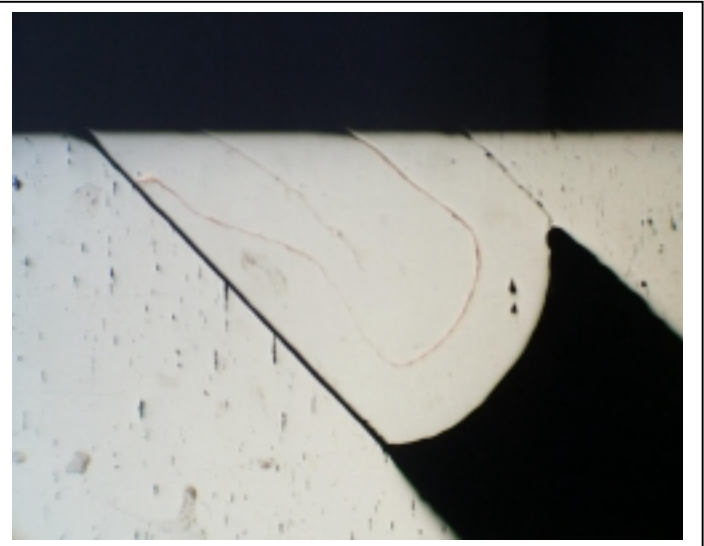
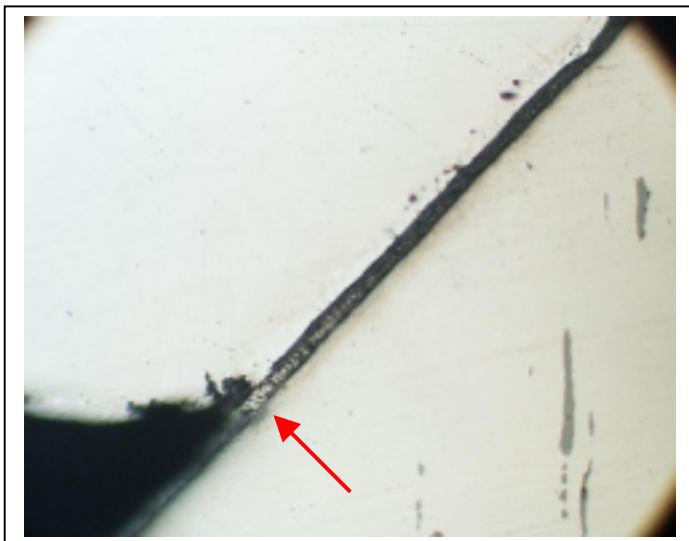
Figure 12
27.5Nm sample

Three samples – one torqued to 10Nm, one torqued to 27.5Nm, and the failure – were microsectioned vertically and polished for inspection using standard metallographic techniques. The 27.5Nm sample was verified as having good compression of the tube flange, as was seen in the acoustic image (figure 12). The 10Nm sample exhibited a point of contact near the inner diameter, but a wedge shaped separation extended from that point to the outer edge of the seal area (figure 13). The failed unit exhibited a large, wedge shaped separation between the tube and threadsaver. This is similar in appearance to that observed in the 10Nm sample, but to a greater degree. Additionally, a significant gap was present between the tube and tube nut, suggesting that the tube was never adequately compressed (figure 14).

Cross-section showing an overall view and higher magnification views of the seal area on each side of the section.

This view of the tube/thread saver interface shows that what may appear as a separation between the two in the above image is, in fact, a plating layer not visible at the lower magnification. Note that the plating becomes less obvious toward the upper right corner of the photograph; this is a result of preferential polishing of the plating material during the sectioning process.

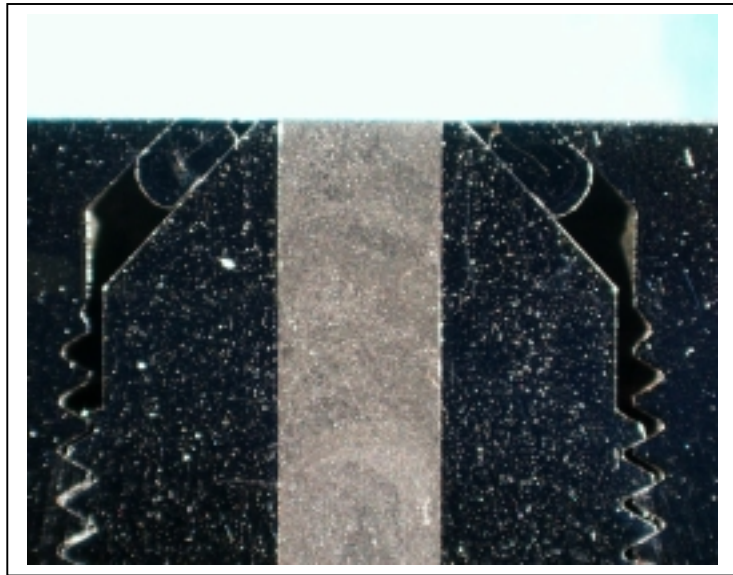
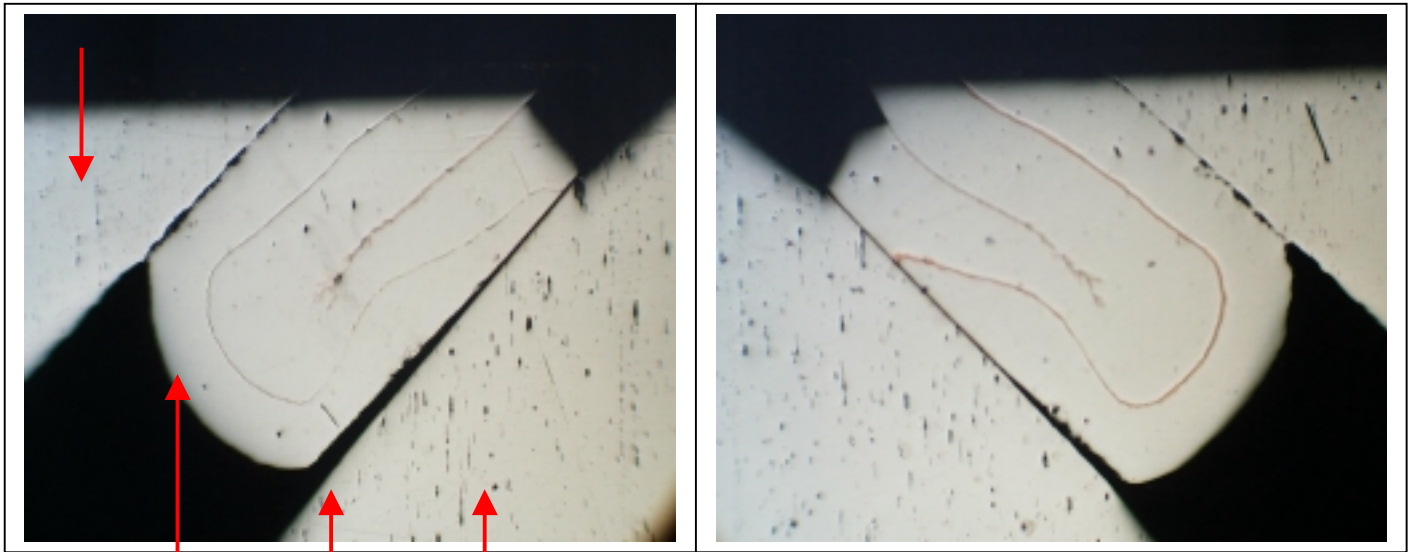
Figure 13
10Nm sample

Cross-section showing an overall view and higher magnification views of the seal area on each side of the section.

Wedge shaped separation

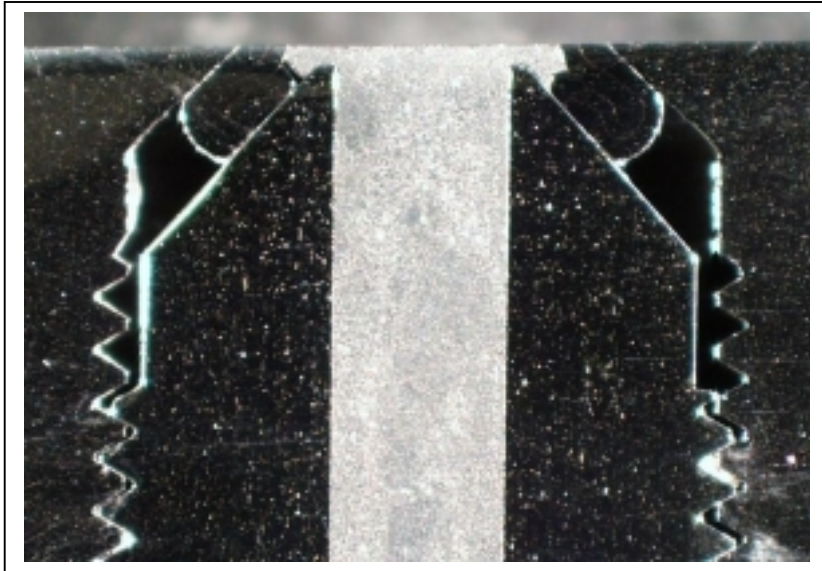
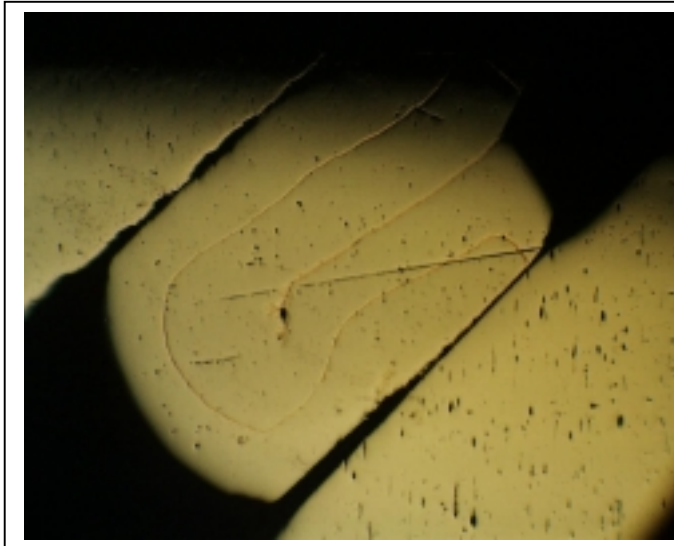
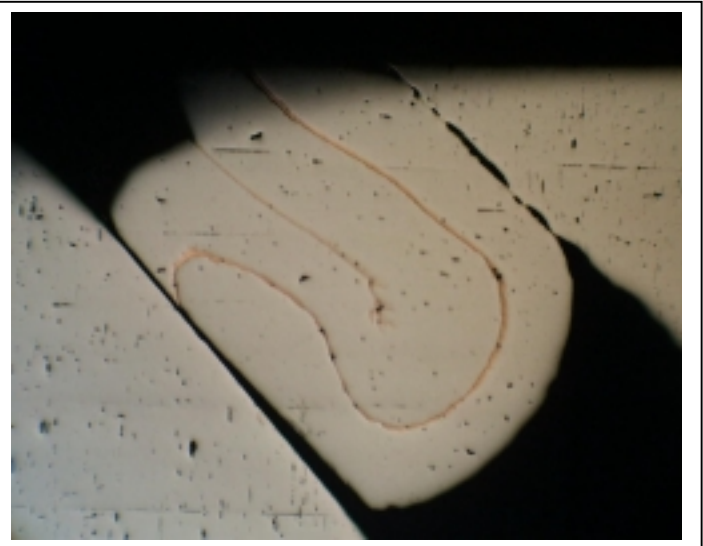
Figure 14
Failed sample

Acoustic microimaging was used to confirm that failing brake line assemblies were leaking due to inadequate compression of the seal. Subsequent destructive analysis validated the AMI results and provided physical evidence of the failure mechanism. Evaluation of experimental samples added confirmation of the root cause of failure, insufficient torque in tightening the nut.

Cross-section showing overall view and higher magnification views of seal area on each side of the section.
