Flip chip defect detection

ACOUSTIC MICRO IMAGING AND DESTRUCTIVE CORRELATION

BY KERRY D. OREN

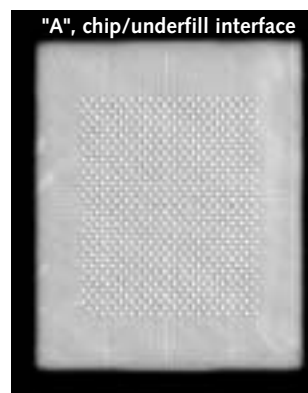
Figure 1. Acoustic micro image of a chip/underfill interface.

In the first case study, a flip chip assembly was evaluated first by focusing through the chip to the chip/underfill interface (Figure 1). Initially, no defects are apparent. However, some defects close to or at the chip surface do not appear prominently when focused on this interface. Therefore, a second scan was executed with a slightly higher focus (Figure 2). Note that the chip surface circuitry and the bumps are less well defined. However, one of the bumps now appears to be very bright, and a small structure is projecting from this bright area.

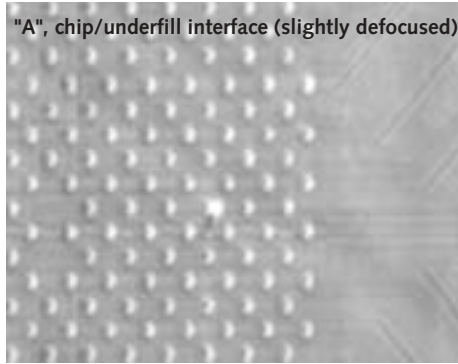
This illustrates the sensitivity of the technique to focus, as very slight changes can expose defects that might otherwise remain hidden. The position of the focus, combined with an analysis of the echo placement from the anomalous area, shows that this defect was very close to the chip surface, and was probably a silicon defect at the surface.

Figure 2. A slightly defocused acoustic micro image of the chip/underfill interface reveals a defect.

The bright white area in the acoustic images is believed to be because of variations in underfill flow and adhesion in this area. The dark projection is an area where the polyimide defect was so small that there was no underfill flow into it, so it shadows the ultrasound.

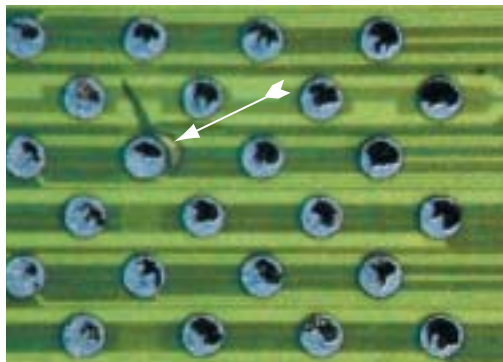
Figure 4 shows the defect at one of the intermediate steps. The defect was found to be in the polyimide on the die surface, and it extended well into the bump region. Note that the structure exactly matches the acoustic images. Figure 4 appears to be a mirror reflection of the acoustic images because it is viewed from the bottom (substrate) side, while the acoustic images are from the top (chip) side.

Figure 4. Planar cross-section showing a defect in the chip surface.

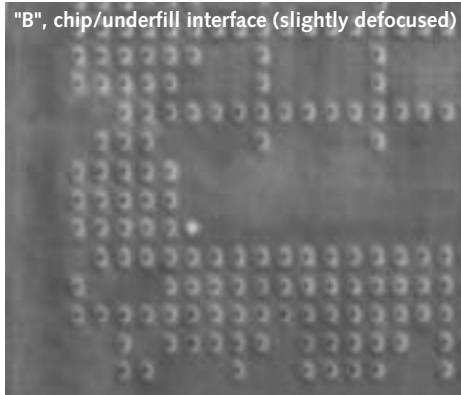
any defects. After raising the focus slightly, one of the solder bumps appears bright white and lacks the “structure” seen in the other bumps (Figure 5).

This was considered to be most likely a defective bump attachment to the chip. It was initially proposed that some contact may be present, but for some reason the bump was not well-bonded to the chip. This information was again based on the focus change effect, and on the positions of the echoes from this defective area.

Figure 5. A slightly defocused acoustic micro image of a chip/underfill interface.

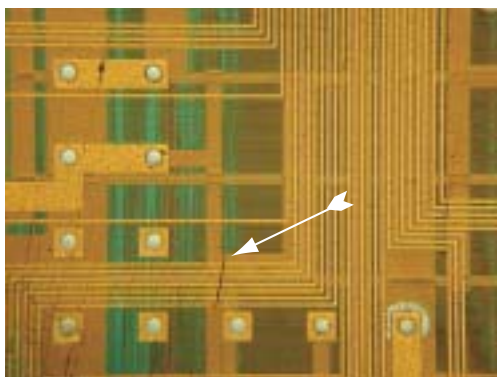
This flip chip was also destructively analyzed, and again a planar cross-sectioning technique was used. The suspect bump’s appearance was monitored as the surface of the chip was approached in the polishing process. Figure 6 shows the plane at the chip’s surface; the solder bump is now no longer visible, and no pad exists.

It was subsequently learned that the flip chip manufacturer had used a standard solder bump pattern, and that by design no pad existed here. The bump, however, was in mechanical contact with the polyimide chip surface. The AMI technique was able to distinguish between the metallurgical bond between the functioning solder bumps and the chip, and the mechanical contact of the unused bump and the chip surface. Real-time radiography did not detect this as a “problem” bump.

Figure 6. At a chip surface, no pad is present and the bump has not made a metallurgical contact.
