# Acoustic Microscopy of Tightly Closed Delaminations in Multilayer Ceramic Chip Capacitors

Sridhar Canumalla\*, Kerry Oren<sup>+</sup> and Pedro Ramirez\*

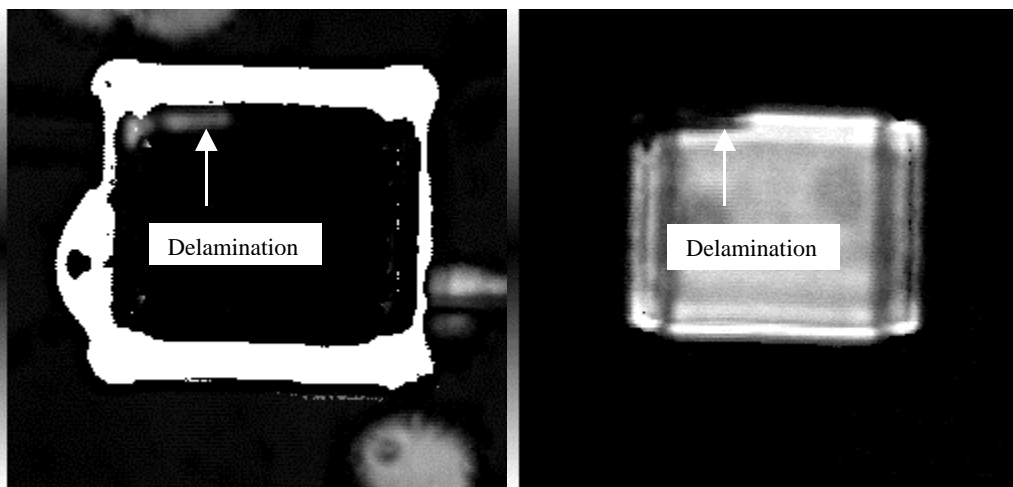
Figure 2a is the bulk scan image of a capacitor and Figure 2b is a loss of back wall echo scan. The bright areas in the capacitor in Figure 2a and the corresponding dark areas in Figure 2b are delaminations or poorly fused areas parallel to the metallized electrodes. The defective capacitors were cross-sectioned using standard techniques, and optical micrographs of the defective areas were obtained. The bright field image of the previously discussed capacitor (shown in Figure 3a) did not reveal the presence of the delamination. The dark field image (Figure 3b) did reveal the delamination, but the evidence was not conclusive. The Rayleigh

Figure 2. a) Internal delamination in a capacitor revealed by a bulk volume scan b) internal delamination revealed as a dark shadow in the loss of back echo scan

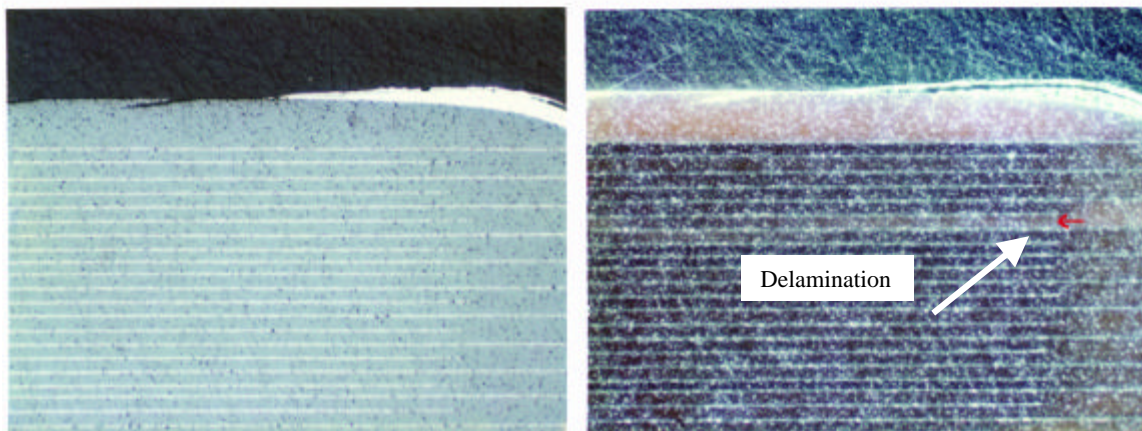
Figure 3. a) Bright field optical micrograph of the defective region does not reveal the presence of the delamination b) Dark field optical micrograph of the defective region reveals the presence of the delamination but not very conclusively.

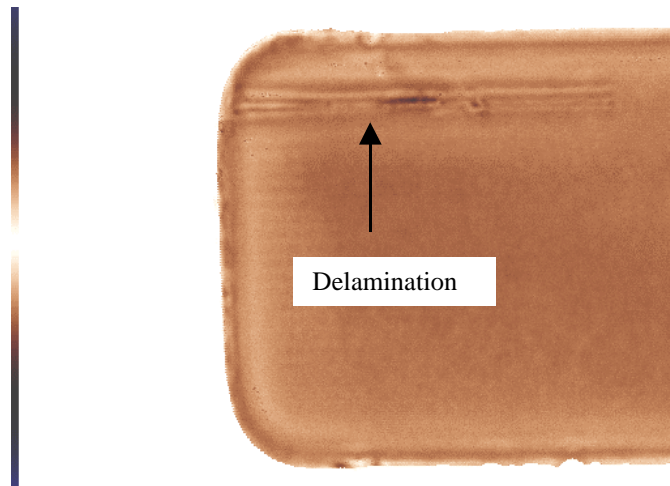
wave image of the polished cross-section (shown in Figure 4), however, conclusively established the presence of the delamination.

Figure 4. The Rayleigh wave acoustic micrograph clearly reveals the presence of the delamination.

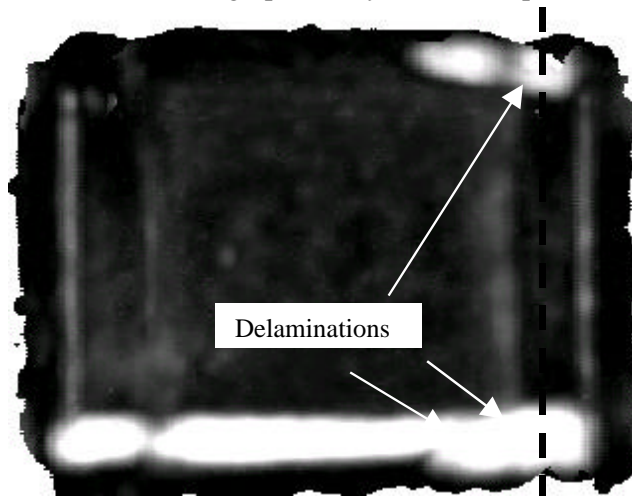
Another example of a capacitor with internal delaminations is shown in Figures 5 and 6. Figure 5 is a bulk scan acoustic image of a capacitor showing multiple delaminations. From the A-scan, it was determined that these delaminations existed at different levels. This capacitor was sectioned, and polished, along the dotted line shown in Figure 5. Optical examination of the destructively cross-sectioned sample proved inconclusive in verifying the presence of the delaminations. Rayleigh wave inspection (Figure 6) with the 230 MHz transducer clearly revealed the presence of three delaminations. In addition, the higher resolution of the 230MHz transducers revealed the presence of the electrodes.

Figure 5. Bulk scan image of a capacitor showing the presence of delaminations and subsequently cross sectioned along dotted line.

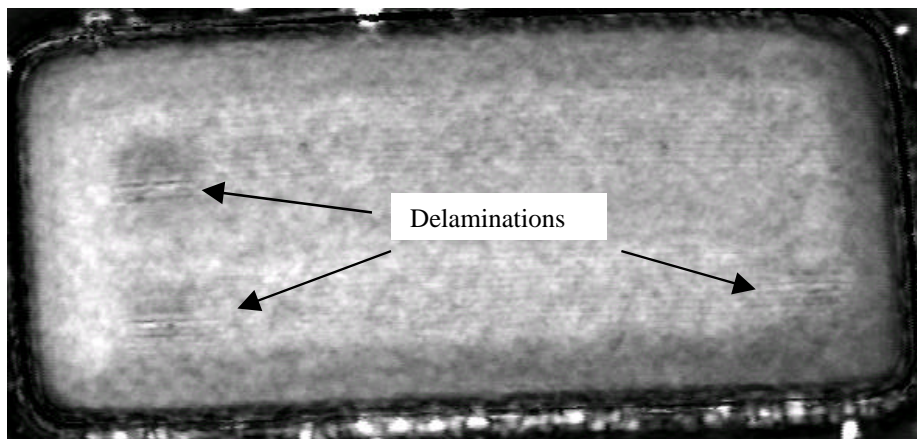
Figure 6. Rayleigh wave image of the cross-sectioned capacitor using a 230 MHz transducer showing clearly the delaminations that could not be observed optically. Additionally, the electrodes are also visible.
