#### Part Qualification/Upscreen:

Package: Plastic-encapsulated 28-pin SOIC

#### Summary:

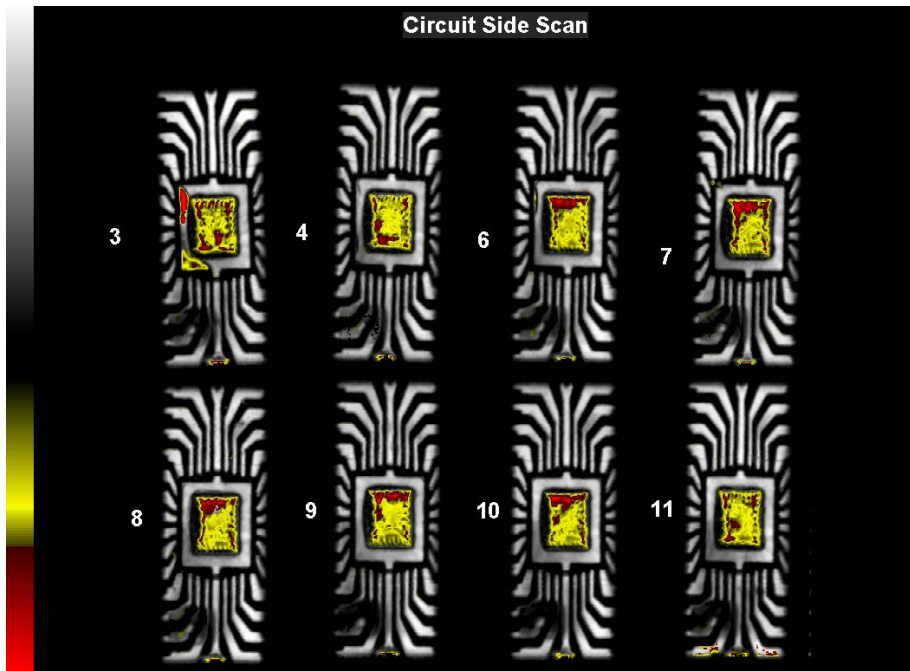
Image 1

Baseline C-mode scan showing the mold compound bond to the die surface, paddle, and lead fingers. The red/yellow appearance of the die in each device is suggestive of delamination. Further investigation using a B-mode scan, or virtual cross-section, showed this appearance to be the result of a die coat present between the mold compound and the die surface. Most die coat materials tend to reflect the ultrasound in a manner similar to a delamination or other air gap, resulting in the red/yellow appearance in this instance. However, the B-mode scan clearly shows the rounded shape that is characteristic of a die coat (see image 5).

Red and yellow areas visible on the paddle in S/N 3 represent delamination between the mold compound and the paddle surface. Delamination is identified by its characteristic waveform (see image 6).

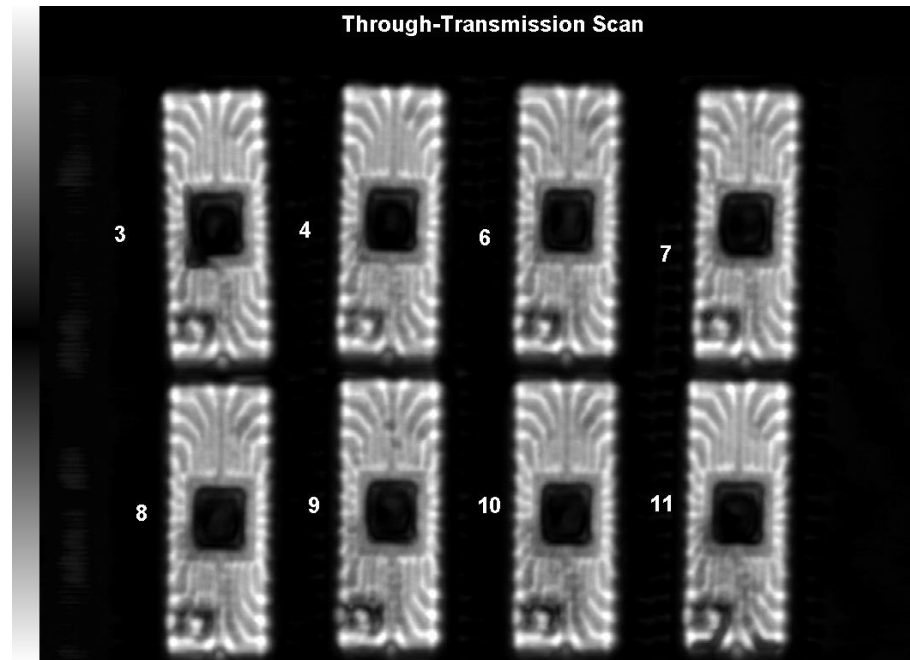
Image 2

Baseline through-transmission mode image. This imaging mode does not isolate a specific layer within the component but displays the degree to which ultrasound is transmitted through the device, using a gray-scale. Darker areas transmit little or none of the sound wave, suggesting the presence of an air gap such as a crack, delamination or void. Lighter areas transmit ultrasound through the entire thickness of the device. The dark areas in image 2 correspond to the red/yellow areas in image 1.

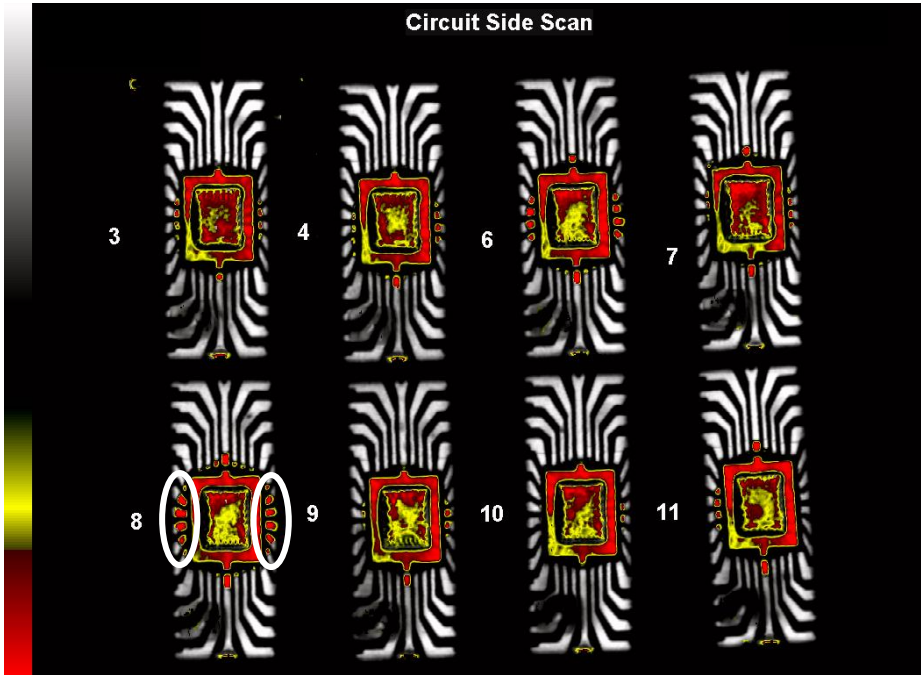
Image 3

Post-process C-mode image. Increased delamination is visible at the paddle and, in some instance, the lead fingers. Since the lead finger delamination is located in wirebonded areas (see circled regions in S/N 8, for example), the delamination does not meet the criteria outlined in NASA PEM-INST-001, which was the referenced specification for this analysis.

The increased paddle delamination is considered a reliability concern by this specification, since the delamination affects more than half of the paddle area.

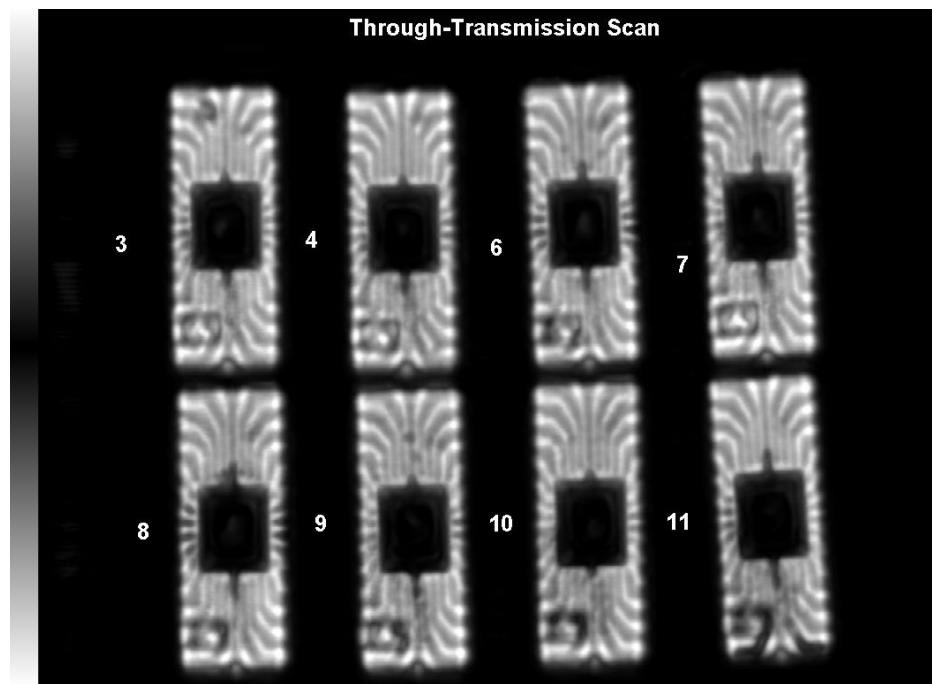
Image 4

Post-process through-transmission mode image. The newly observed areas of delamination identified in image 3 appear dark in this image.

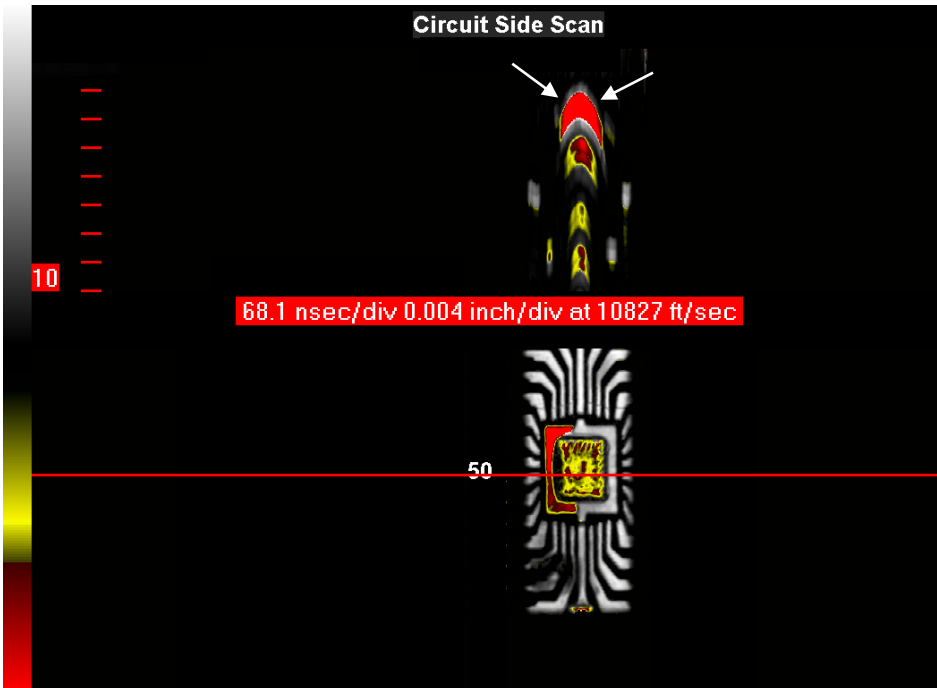
Image 5

The lower half of the image shows the original pre-process C-mode scan. The red, horizontal line identifies the plane of the virtual cross-section.

The upper half of the image is the virtual cross-section. The rounded appearance of the die surface (identified by the arrows) is characteristic of a die coating.

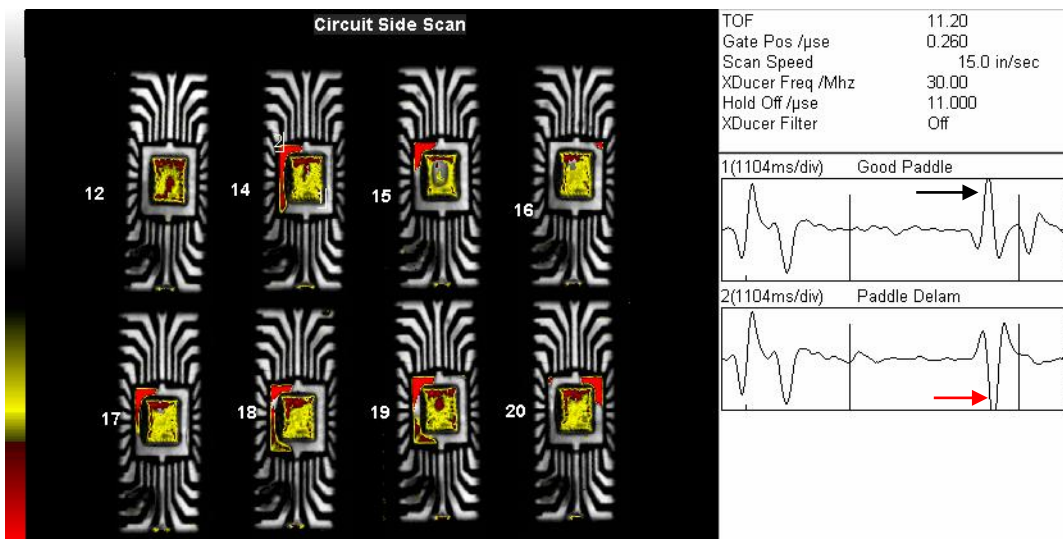
Image 6

A-scans (echo waveforms) from the pre-process inspection.

Waveform 1 shows a good area of the paddle. The positive-polarity echo (see black arrow) is characteristic of a good bond between the mold compound and the paddle surface.

Waveform 2 shows a delaminated area of the paddle. The negative-polarity echo (see red arrow) is characteristic of a delamination between the mold compound and the paddle surface.

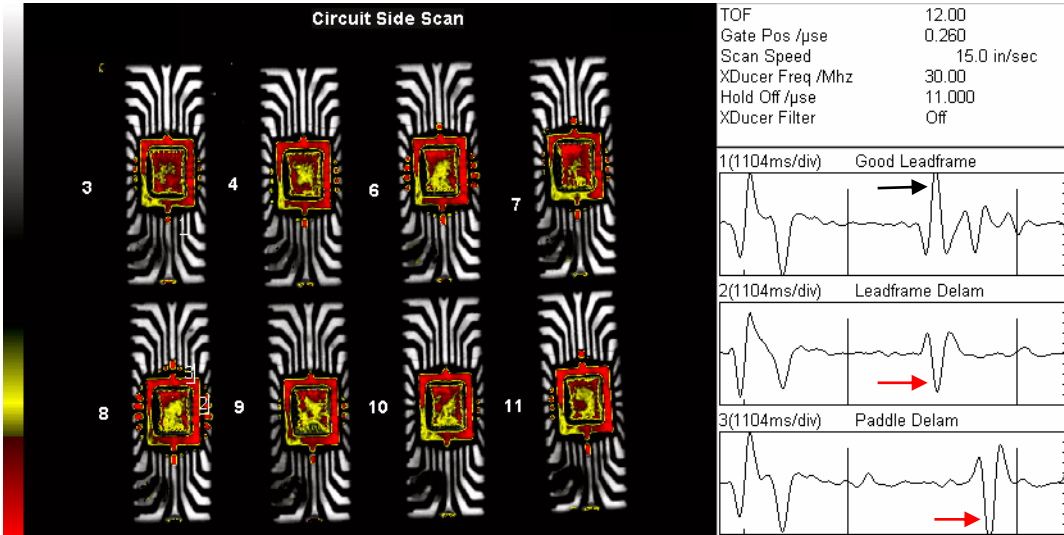
Image 7

A-scans (echo waveforms) from the post-process inspection.

Waveform 1 shows a good lead finger. The positive-polarity echo indicates a good bond between the mold compound and the lead finger.

Waveform 2 shows a delaminated lead finger. The negative-polarity echo indicates a delamination between the mold compound and the lead finger.

Waveform 3 shows the paddle. The entire paddle surface is delaminated as indicated by the negative-polarity echo.
