The Difference A Color Map Makes

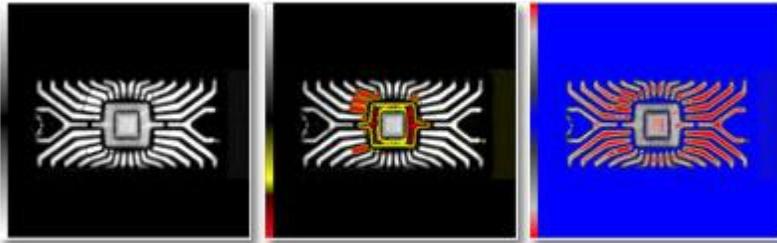
Center image shows the actual internal condition of a PEM. Delamination is visible at the die paddle and some leadframe elements. The images at left and right show the same part with two different color maps applied. At left, the part has been made to look completely good. At right, the part has been made to look much worse than it really is. An understanding of the color map used and, preferably, of the echo waveforms at various locations, is necessary to accurate image interpretation.

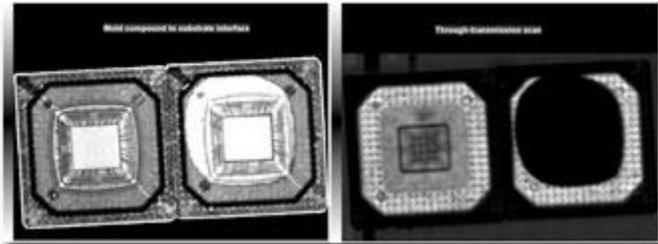
BGA Delamination

Moisture-induced delamination in a plastic-encapsulated BGA package. Image at left shows the mold compound to substrate interface. The bright white area represents delamination at this interface. Image at right is a through-transmission image of the same two devices. Delaminated region appears black in this image.

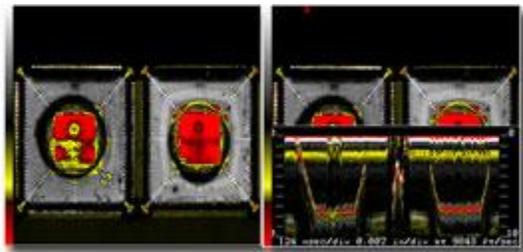
Popcorn Cracking

“Popcorn cracking” in a plastic quad flat pack (PQFP). In the image at left, delamination of the mold compound from the paddle is shown by the red areas at center. The black region surrounding the paddle is a “shadow” cast by the package crack. The image at right shows a virtual cross-section of the package cracks, which can be seen extending upward from the paddle at a steep angle.

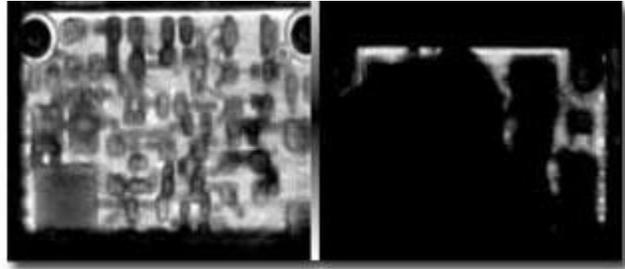
Delamination in Rigid/Flex Board

Through-transmission image of multilayer rigid/flex boards following attachment of components. A good board is on the left and a bad one on the right, where the large black area is delamination at the rigid/flex interface.

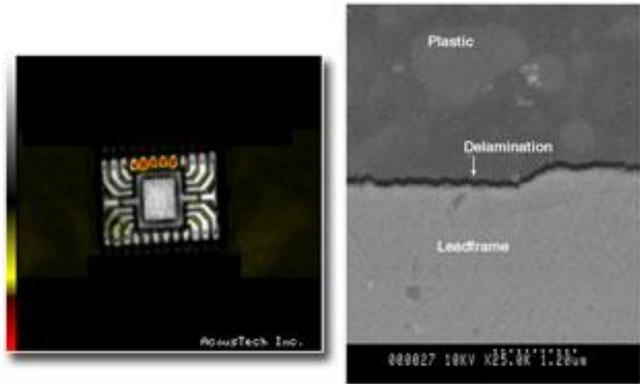
Leadframe Delamination in PEM

Acoustic image of plastic SOIC showing delamination of mold compound from leadframe (red areas in image at left). SEM image at right shows cross-section of the delamination. *SEM image courtesy of Hi-Rel Laboratories.*

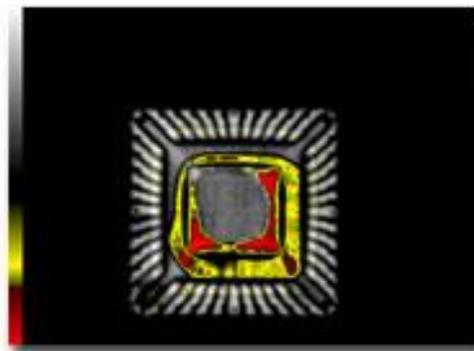
Die Surface Delamination in PEM

Acoustic image of a PQFP showing delamination over a portion of the die surface and die paddle.

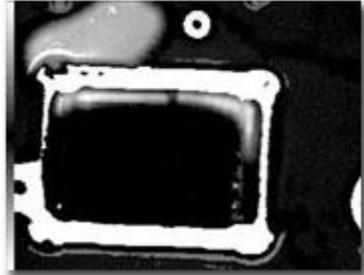
Ceramic Chip Capacitor Delamination

Acoustic image of a ceramic chip capacitor mounted to a printed circuit board. Delamination along electrodes is visible at the top edge of the component.

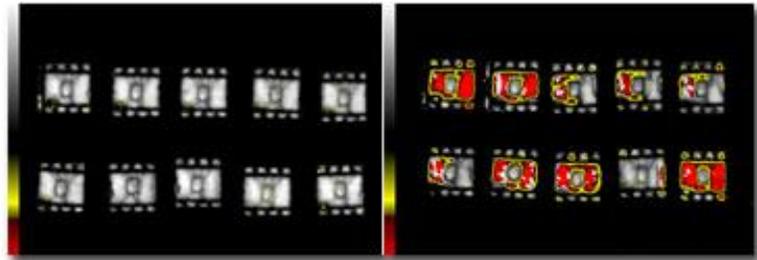
Moisture Sensitivity Level Testing

Moisture Sensitivity Level (MSL) testing of SOIC-8 devices. Images show pre-test (on left) and post-test (on right) condition of these parts. The delamination resulting from the test would cause the parts to fail the tested MSL level per J-STD-020.

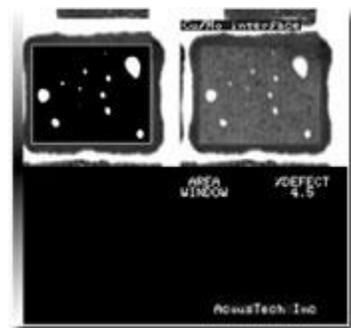
Substrate and Header

Acoustic image showing bond between a substrate and header. Voids appear white. Digital Image Analysis provides a quantitative measure of the amount of voiding, 4.5% in this case.

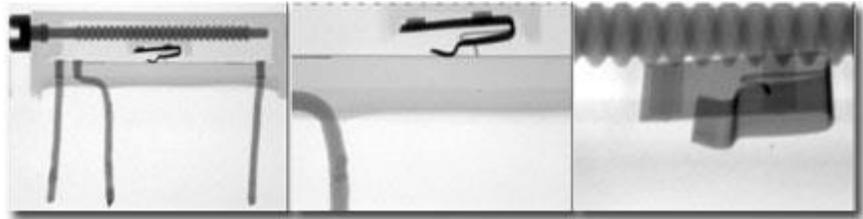
Potentiometer X-Ray

X-ray images of a potentiometer showing a bent contact.

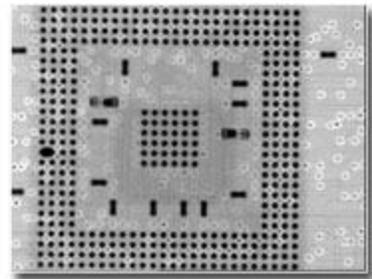
Solder Bridging in a BGA

Real-time x-ray image of a BGA device mounted to a printed circuit board. Excess solder is visible along the left edge, bridging adjacent solder balls.

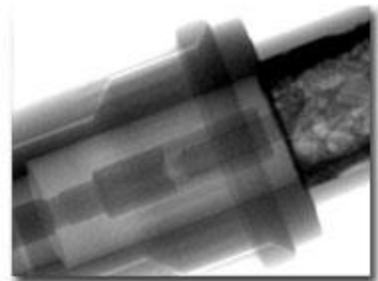
Coax Connector X-Ray

Real-time x-ray image of a coaxial cable connector.

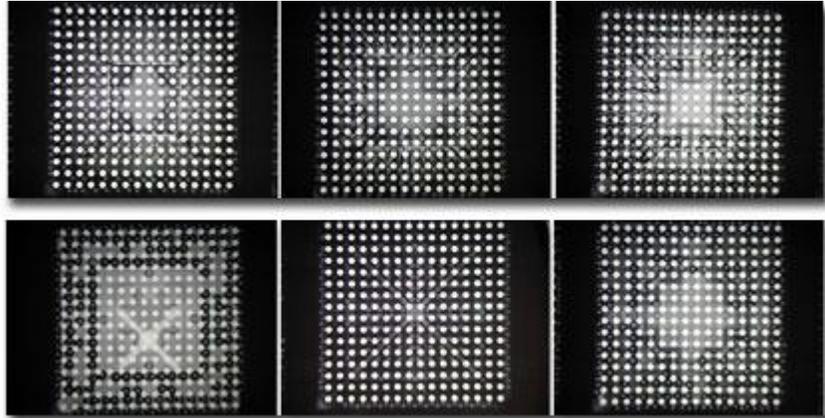
Counterfeit Component X-Ray

All of these plastic-encapsulated BGA devices were reported to be from a single production lot. Note that each contains a different substrate pattern. In #2 and #3, the bondwires are severely damaged. In #4, #5 and #6, no bondwires are present.
