EVALUATION OF AN AUTOMOTIVE FLUID LINE ASSEMBLY USING ACOUSTIC MICROIMAGING

Jon A. Roth
AcousTech Inc.
10542 Coldwater Road, Suite B
Fort Wayne, IN 46845
Phone: 219.637.2167
Fax: 219.637.4128
jon.roth@acoustech-inc.com

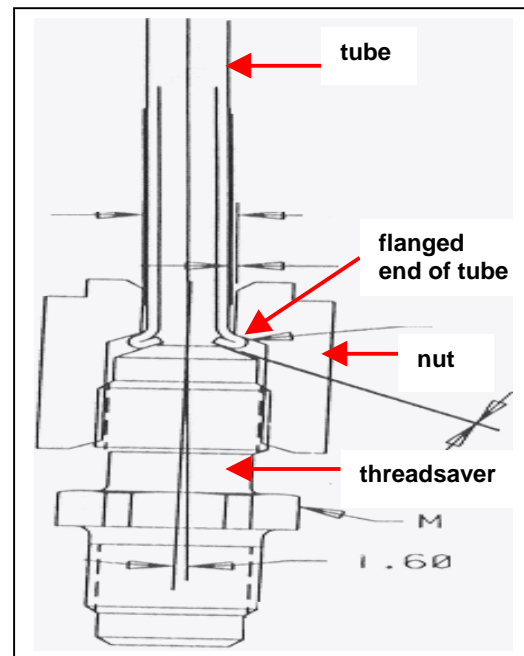
The brake line assembly was constructed of a double wall steel tube with a flange formed at one end. The flange was mated to a threadsaver and fastened by a nut. By tightening the nut onto the threadsaver, the tube flange was compressed, thus forming the seal between the tube and the threadsaver (figures 1,2). The sealing surface was at a large angle (approximately 45°) with respect to the longitudinal axis of the tube.

Figure 1 Diagram of assembly showing threadsaver, tube with flanged end, and nut.

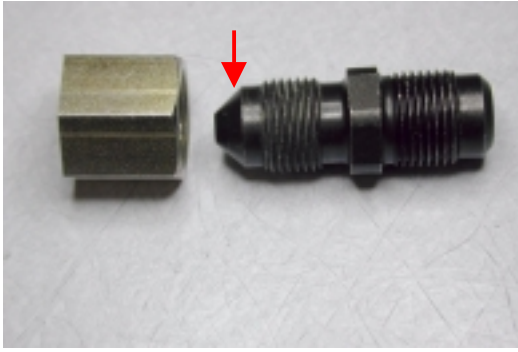
Figure 2 Photo of unassembled nut and threadsaver (tube not present). Note steep angle of mating surface, at arrow.

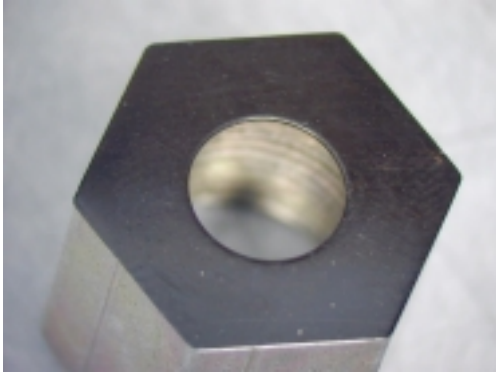
part's construction. To increase confidence in the AMI technique, a "calibration standard" was developed using a stock tube nut. The top portion of the tube nut was ground off and polished in order to simulate the sample preparation used on a completed assembly, as described previously (figure 4). The nut was then imaged under the assumption that it would be the ultimate "bad" sample – no contact at all to the tube flange, since no tube was present.

Figure 4 Modified tube nut used as calibration standard.

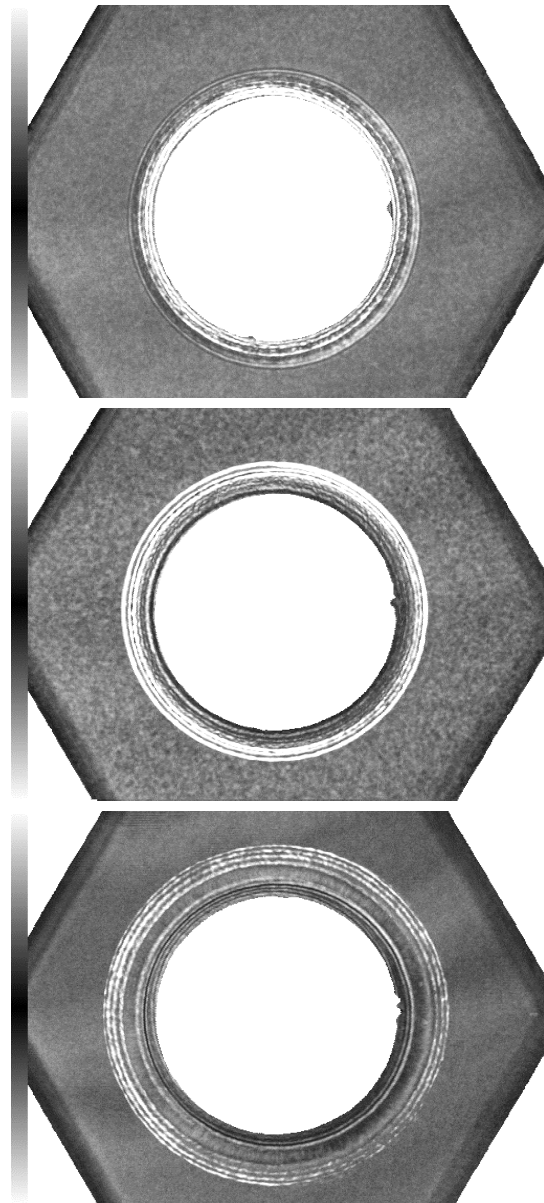
Figure 6 Acoustic images of calibration nut obtained with different focus depths. Top image—shallowest focus (near top of angled surface). Middle image--focused near center of anticipated seal region. Bottom image—deepest focus (near bottom of angled surface).

focus depth corresponding to the center of the anticipated seal area. While the machining grooves tend to detract from the image quality, the portion of the angled mating surface that is visible in this image appears primarily white, due to the large negative reflection from the nut/water interface, as expected. By comparison, the top image resulted from a focus near the inner diameter of the nut (top end of the angled surface), while the bottom image was obtained by focusing near the bottom end of the angled surface. The same wide gate was used in all three images.

Clearly, the difference in appearance between the three images is significant. In particular, it was noted that in the image with the deepest focus (bottom image), a uniform gray band is present in much of what would be the expected seal region. This emphasized the importance of choosing a focus depth near the center of the anticipated seal area, in order to ensure accurate imaging over as much of the seal as possible. In addition, a very large gain was used in order to maximize the amount of information obtained from the echo returns at the extreme ends of the gate.

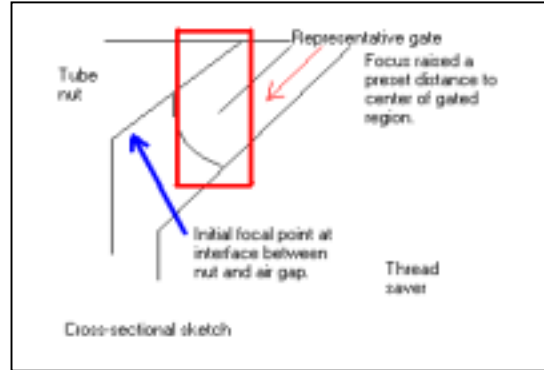
It should be noted that once these parameters were established using the tube nut calibration standard, subsequent imaging of complete assemblies required individual adjustment. Recall that preparation of an assembly for imaging required removal of excess material from the top surface to the area of interest, so that it was necessary to locate the proper gate position and focal point on an individual basis. This was accomplished by first locating the gap at the bottom of the angled surface and then raising the focus a predetermined distance to the center of the area of interest (figure 7).

Figure 7 Cross-sectional sketch of seal area

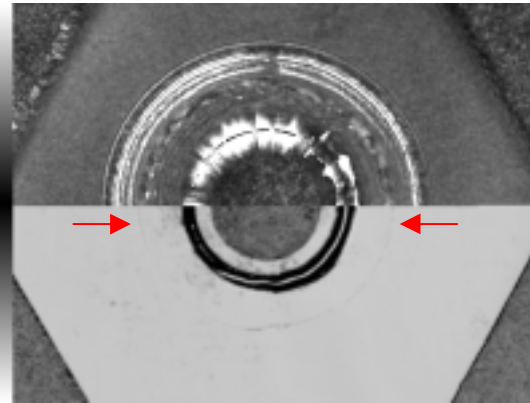
Figure 8 Hybrid image showing seal area image on top and surface image on bottom. Demarcation line on surface image (at arrows) identifies interface between tube and tube nut. Area of interest is from this point outward.

Figures 8 and 9 show acoustic images of one of the samples torqued to 10Nm. Figure 8 is a hybrid image in which the top half is the image of the seal area, while the bottom half is a surface image. This is an instructional image intended as an aid in locating the seal region. Figure 9 shows the entire seal for this sample. Note that a
